MIGRATORY CORROSION INHIBITOR (MCI®) PRODUCTS FOR CONCRETE

CASE HISTORY

Structural Repairs to Trinmar Platform 15

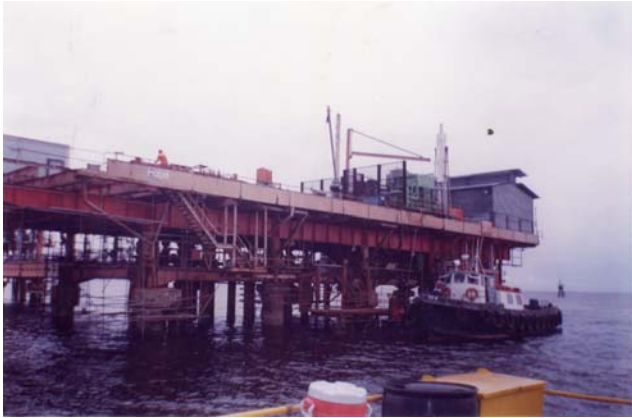
Trinmar Platform 15

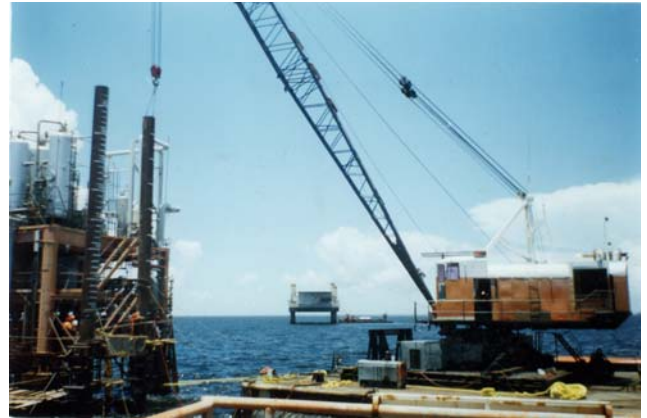
Piles being driven into the sea bed

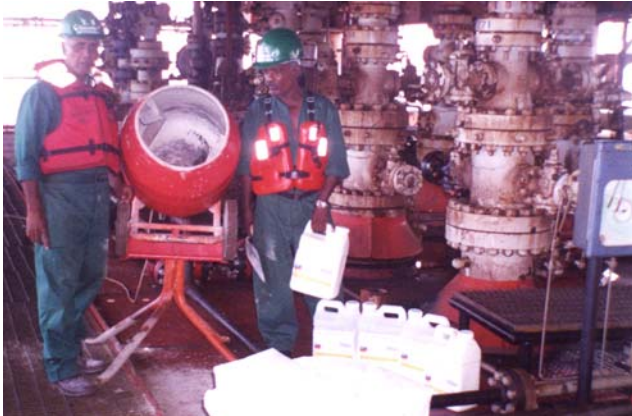
Mixer and MCI® - Repair materials

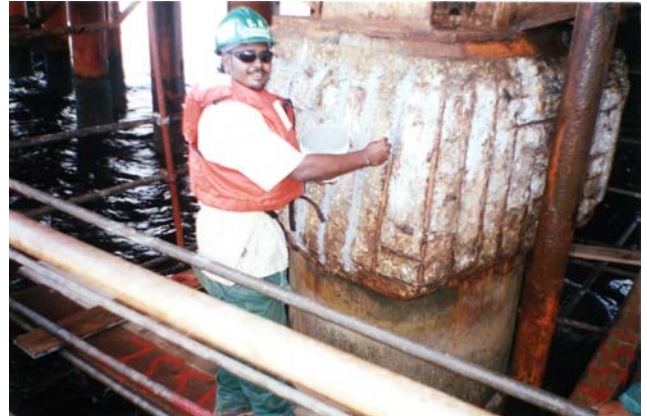
Trinmar has extensive Offshore Oil Production in the Gulf of Paria in Trinidad and Tobago. Some of these production platforms are over thirty years old and chloride attack has caused extensive rebar corrosion to the piles and pile caps, resulting in spalling of the concrete.

MCI®-2023 rebar coating applied on Pile-cap

1. Spalling concrete was hydroblasted at 20,000 psi.
2. VpCI®-611 was applied to protect against rebar flash rusting.
3. MCI®-2023 Passivating Grout was applied to the exposed rebars.
4. MCI®-2020 was sprayed onto the spalled areas.
5. A tie coat of MCI®-2039 was brush applied for adhesion.
6. MCI®-2039 was then trowel applied in lifts of 2" and built up to 6" in some areas.
7. MCI®-2020 was then sprayed onto the entire surface.
8. After fourteen days, MCI®-2021 was sprayed on the entire surface.

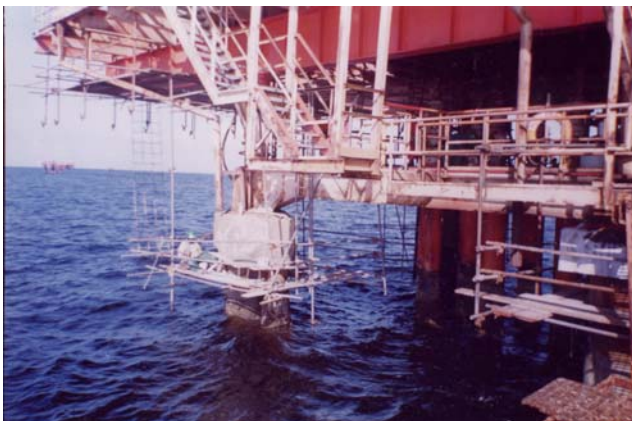
Pile-cap being repaired with HPRSTM™

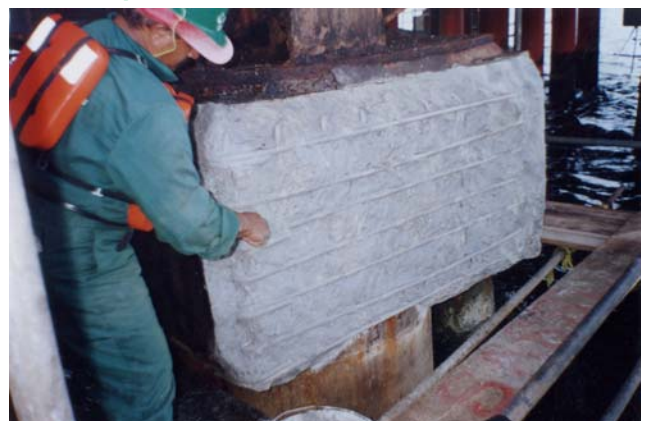
MCI® - Tie Coat 2039
